Replacing 32 pipes on the Druzhba oil pipeline in under 88 hours

By Dr Ing. Petr Crha and Dipl. Ing. Ales Brynych CEPS a.s., Jesenice, Czech Republic

In September 2007, a unique event in terms of its scope and speed was carried out on the Czech section of the 20 inch diameter Russia to Germany Druzhba Oil Pipeline in South Moravia, where 32 pipe sections were replaced in a very short time.

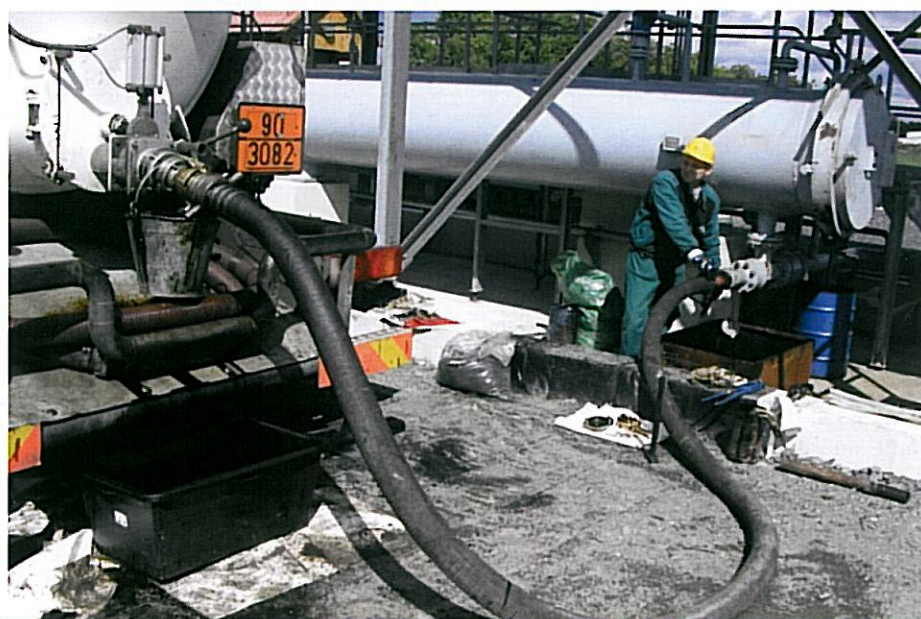
Displacement of oil from the 28 inch diameter pipeline into road tankers.

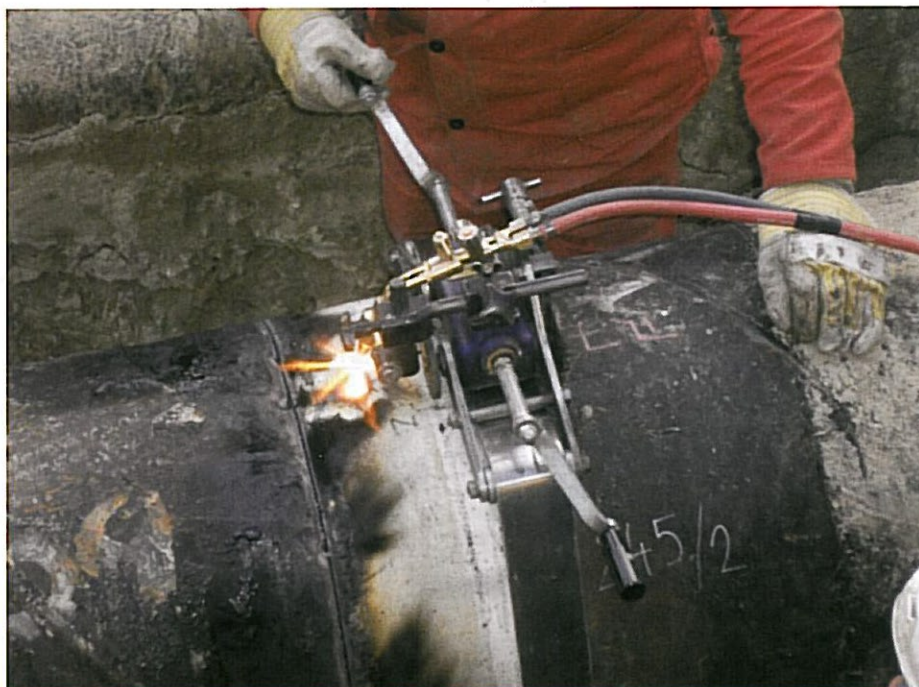
Having ensured that all pipe, with the exception of pipe no.974, had been totally decontaminated, it was possible to use oxyacetylene flame for the cutting, which significantly speeded up the work. During

Pipe cut-out using oxyacetylene flame.

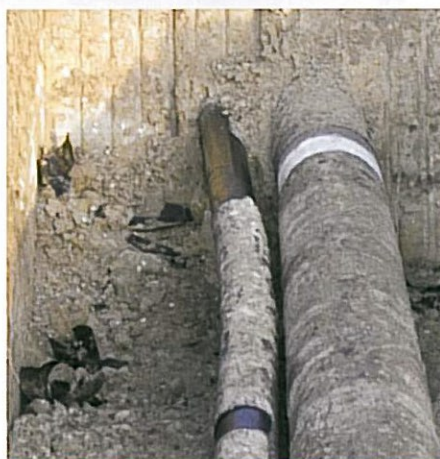
During excavation it was found that there was a parallel 8 inch pipeline that in some places was only 100 mm away. This meant that great care had to be taken to avoid damage.

The adjacent 8 inch diameter line, at the location of pipe no.118.

Replacement of pipe no.118 which was the nearest to the pumping station, was carried out in a similar way.
