Comprehensive approach to ensuring the integrity of high-pressure gas pipeline DN 400

CEPS a.s.
Jesenice u Prahy
Czech Republic

T.D. Williamson Polska
Warsaw
Poland

A concrete example of this integration is revalidation of 55 km older gas pipeline DN 400 in south-western Poland

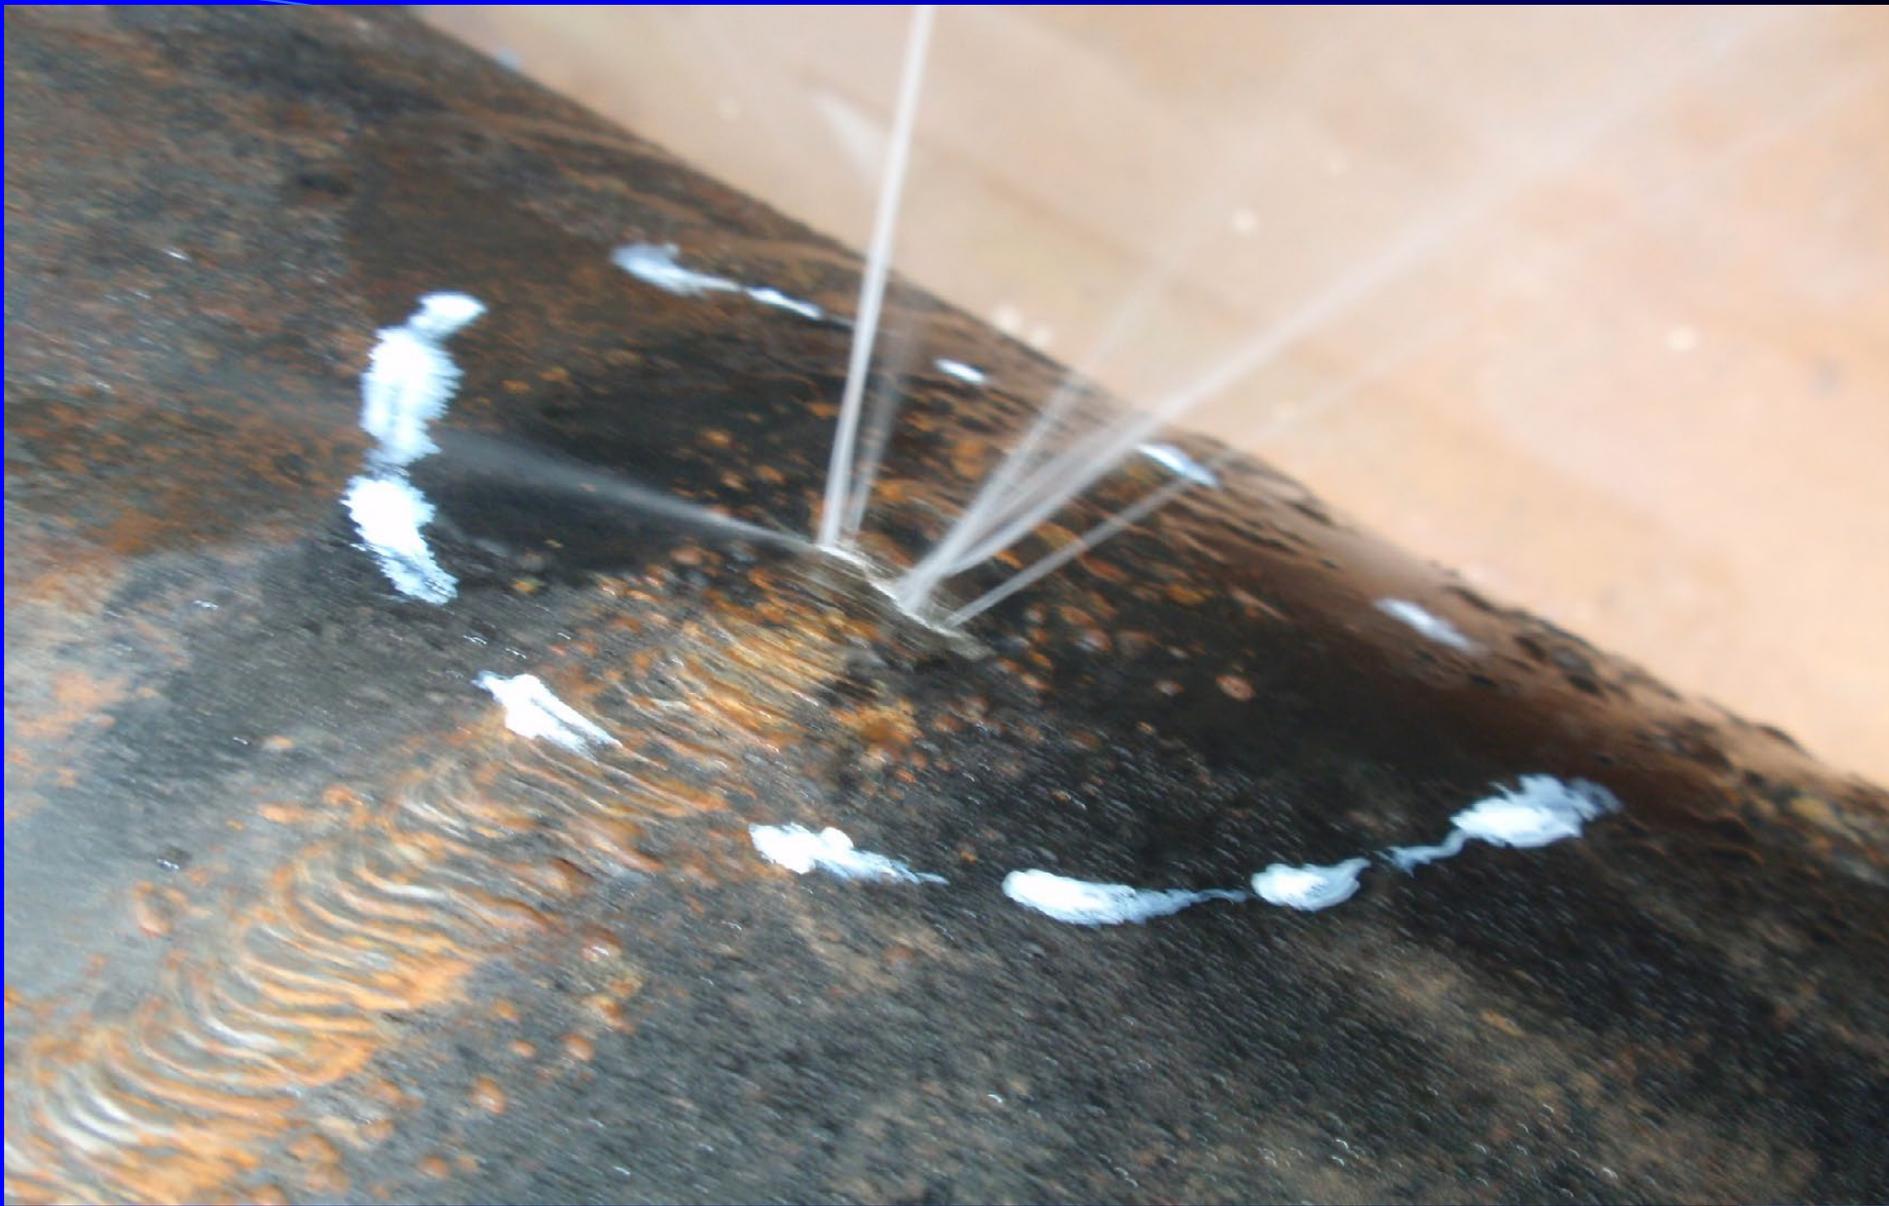
Destruction of circumferential weld

When pressure approached to calculated pressure of ultimate strength the **circumferential weld was destroyed.**

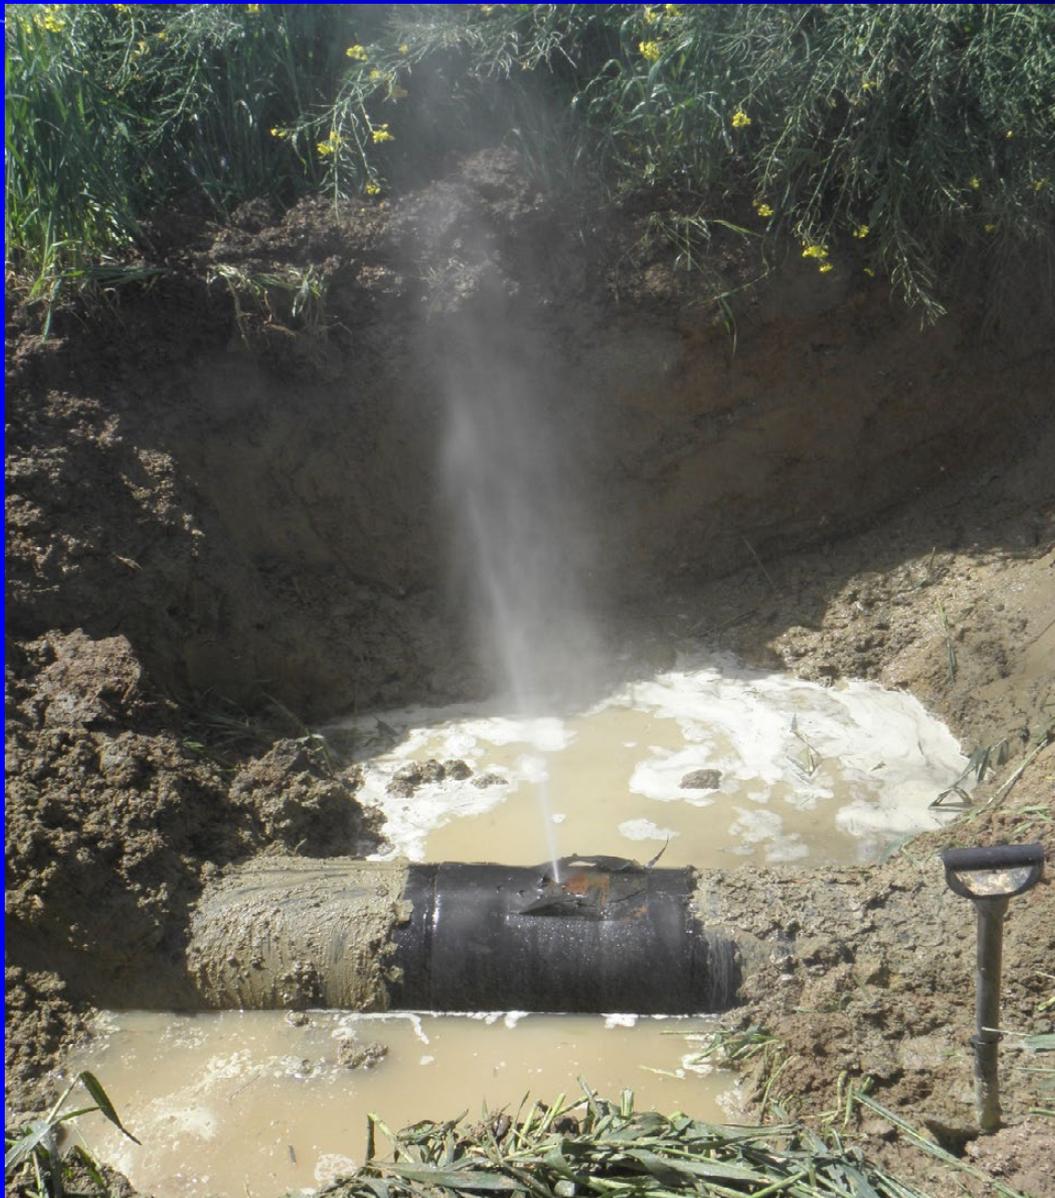
Fountain in the rapeseed field

1st destruction

- **During the strength test** of the integrity test was detected a significant drop of pressure.
- Based on calculation was set the **size of water leak in a amount of approx. 411 l/h.**
- After several days the leak was found during walking route along the pipeline.

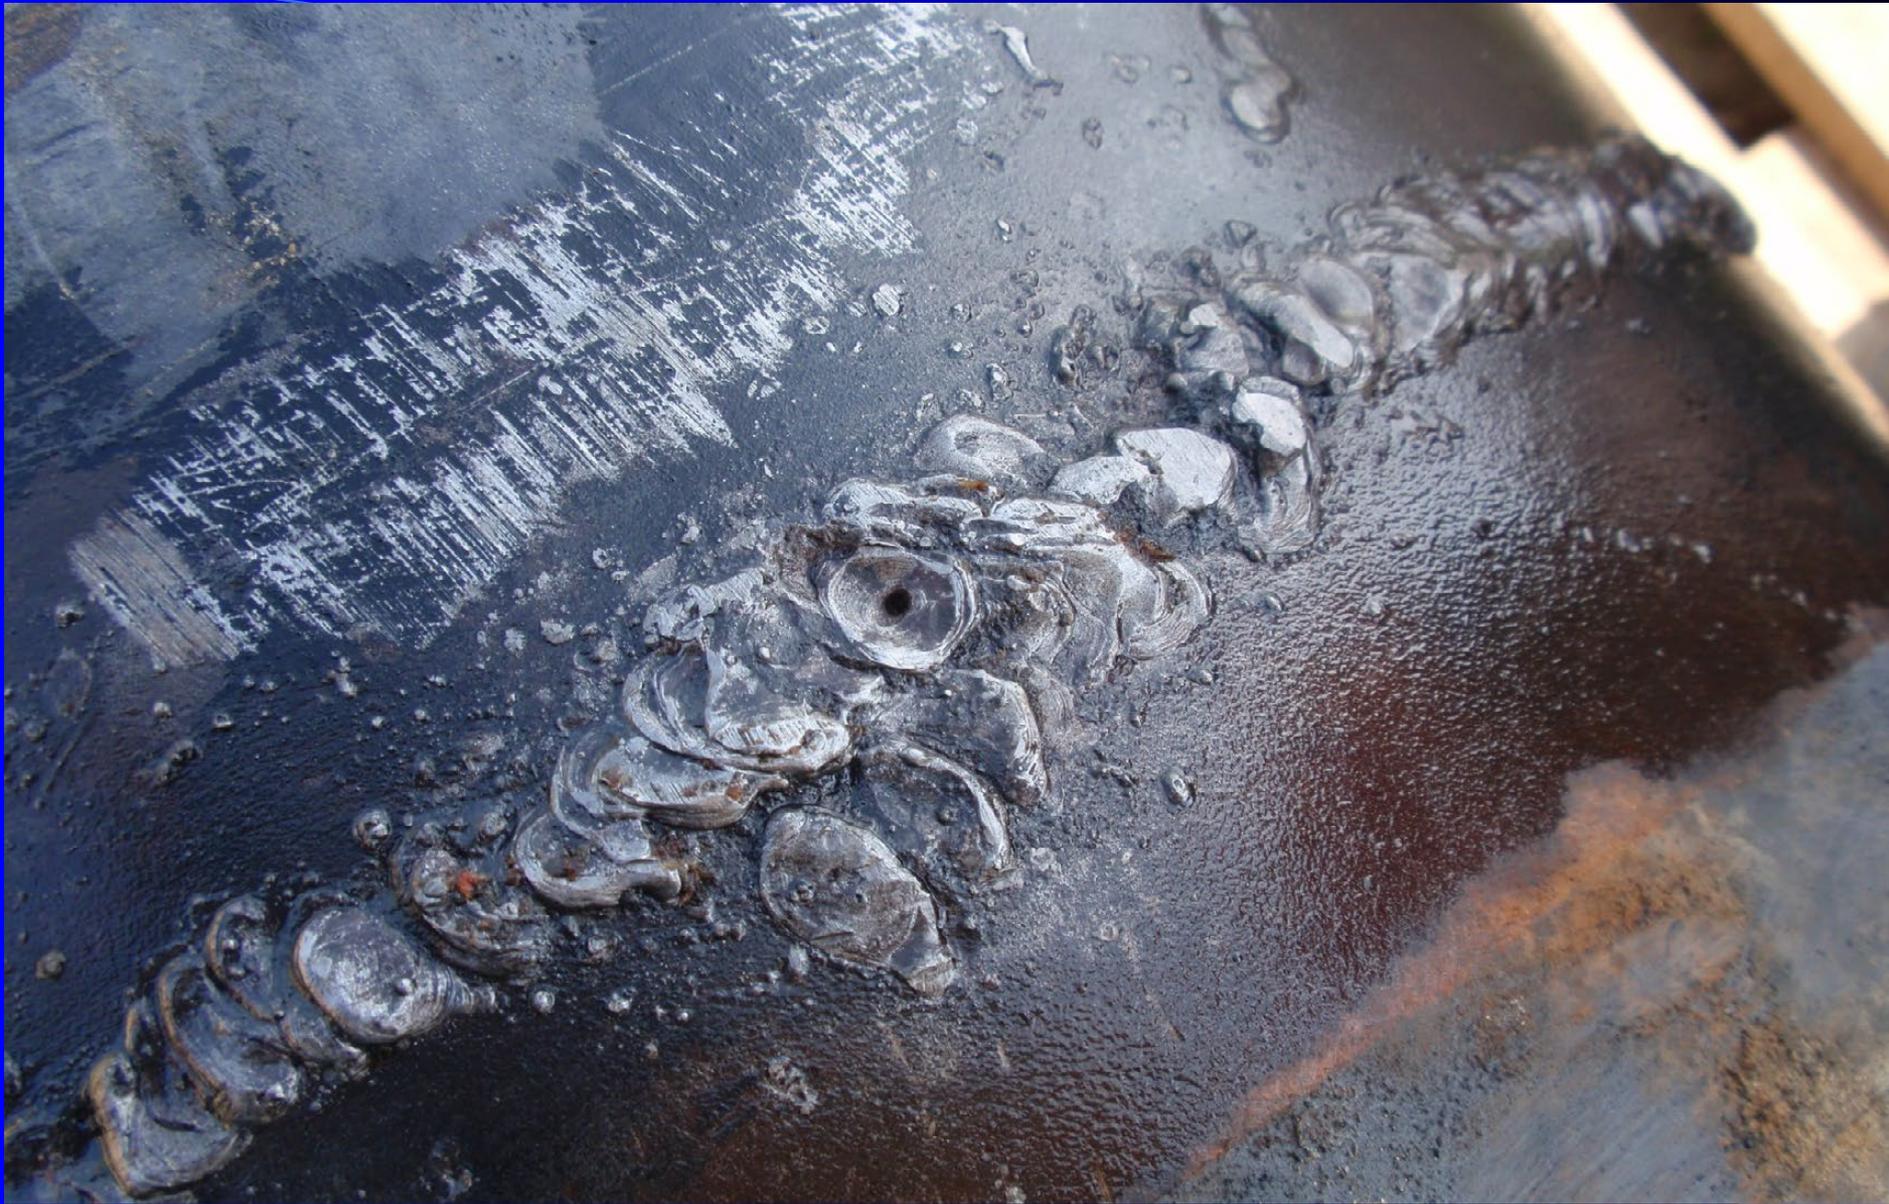
Assembly weld with defect

After reducing the pressure a very **impressive assembly circumferential weld** was found at position 12.

There was immediately carried out **back-checking of results of internal inspection of this site**, but this thorough checking **did not reveal any anomalies in record of the MFL tool.**

This finding again confirmed the long experience of CEPS, that **intelligent tool of the type MFL is not able to detect all pipeline defects of this type and scope.**
