Offline internal inspection in the Czech Republic

Aleš Brynych, CEPS a.s., Czech Republic, discusses how offline internal inspection of pipelines is an important tool for investment decisions.

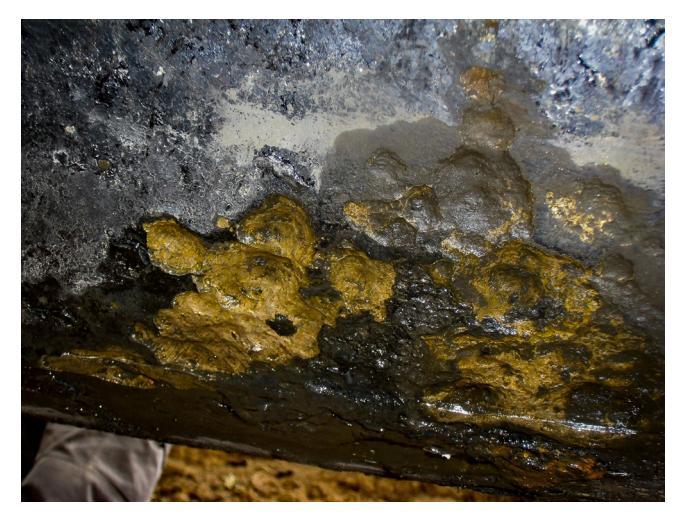
Figure 1. DN 600 pipeline corrosion.

The natural gas leakage was detected on the Kasejovice-Mikulášov pipeline in spring 2016, in south Bohemia near the Čížová village. The pipeline segment was excavated and extensive corrosion damage was discovered (Figure 1). Subsequently, another preventive excavation found similar corrosion damage to a pipeline nearby. Both corrosion defects were repaired using composite filled steel sleeves (Figure 2).

A 20 m long pipeline segment was excavated in the location where the gas leakage was detected and pipes of both types were found. As expected, the coating of spiral welded pipes was in good condition. On the contrary, the coating of bends was in a bad condition. Removal of the coating revealed several general corrosion spots. In addition, almost zero cathodic protection (CP) potential was detected in the location. Therefore, it was concluded that the cause of the corrosion (and the resulting gas leak) was poor quality coating of the bends together with very low CP potential.

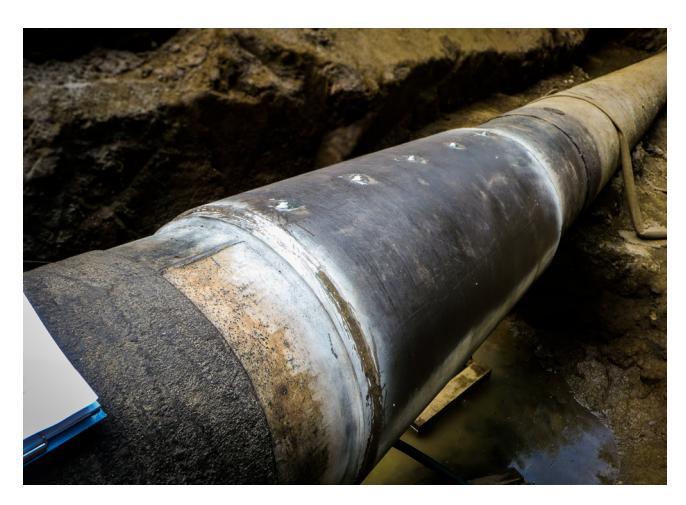
Figure 2. A composite filled steel sleeve on a pipe.

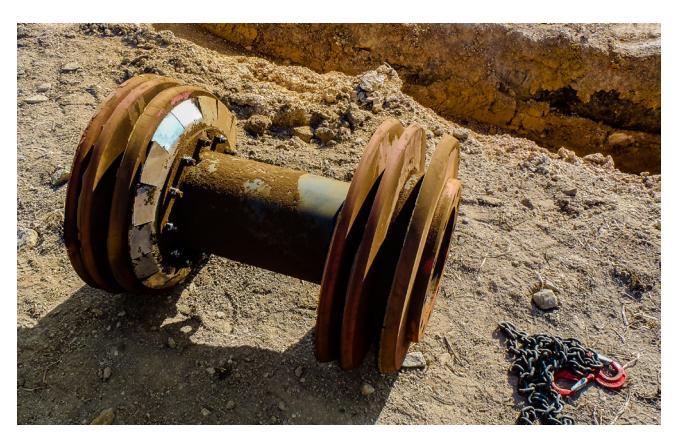
Figure 3. A gauging pig.

The pipeline was cleaned by a gauging pig equipped with a pig tracker. A diameter of an aluminium plate fitted to the pig had been defined by the ILI subcontractor. Approximately 2 dm³ (cubic decimetres) of debris were removed. All the segments of the aluminium plate were deformed after the run (Figure 3). Nonetheless, neither cuts nor scratches were present. After examination of the aluminium plate, the ILI subcontractor approved to proceed with a calliper pig run.

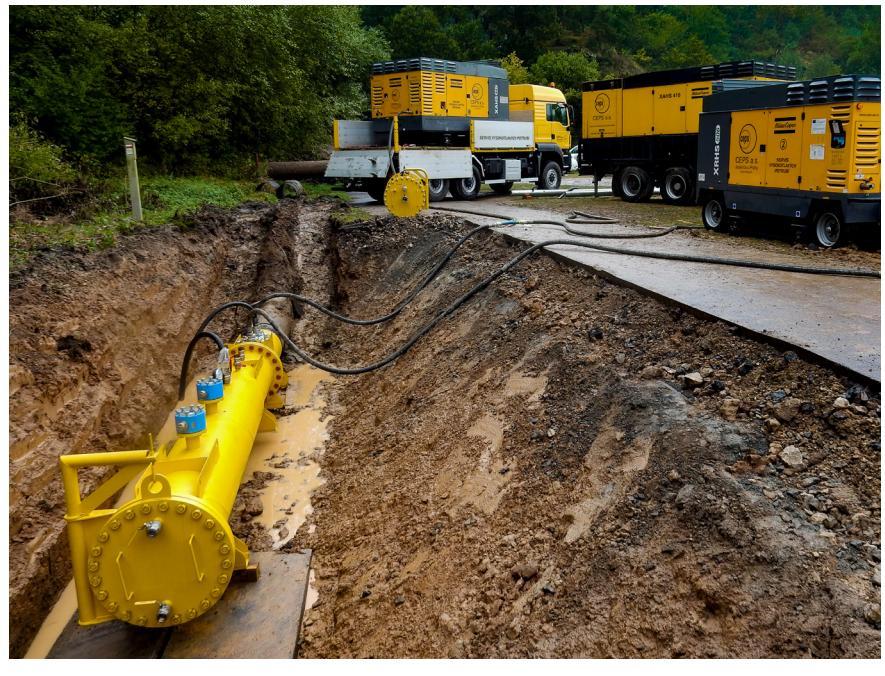
Figure 4. A calliper pig run.

The calliper pig was propelled by compressed air (Figure 4). Based on the calliper pig data the ILI subcontractor confirmed that there were no unacceptable geometric defects in the pipeline. Hence, the UT ILI tool run was approved.

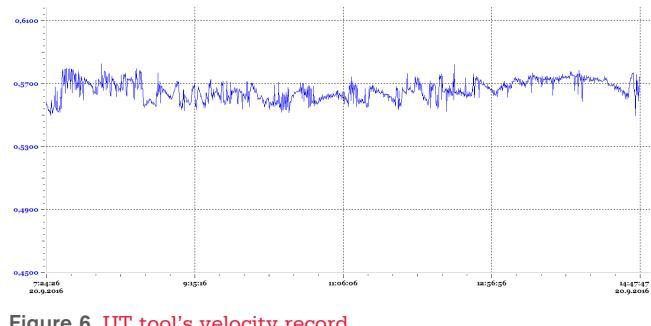
ILI tool velocity was recorded and is presented in Figure 6, which explicitly shows that the tool's velocity was stable and in an optimal operation range, as recommended by the ILI tool supplier.

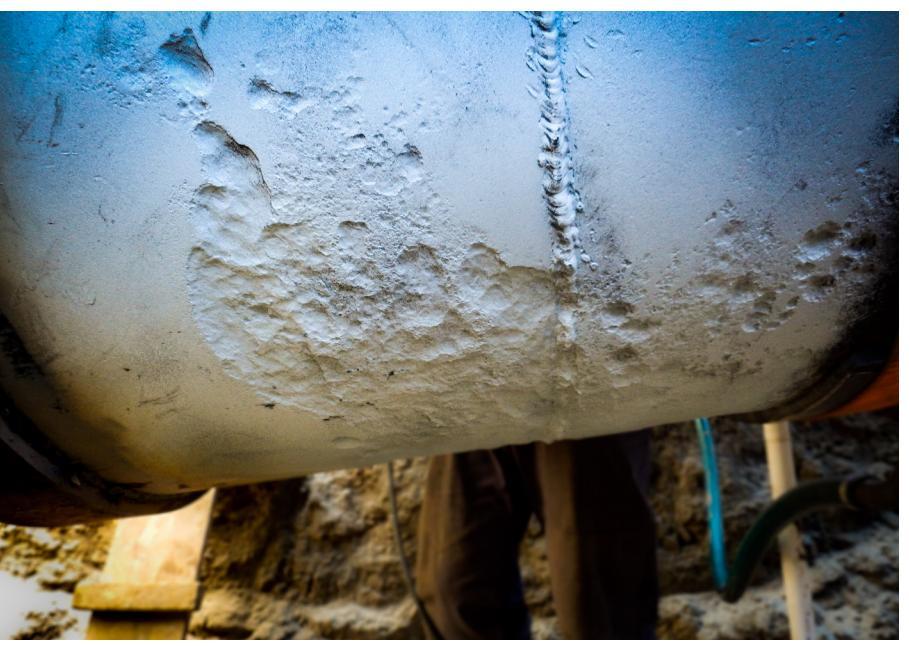
Figure 7. The defect before the sleeve installation.
