Offline internal inspection in the Czech Republic

Aleš Brynych, CEPS a.s., Czech Republic, discusses how offline internal inspection of pipelines is an important tool for investment decisions.

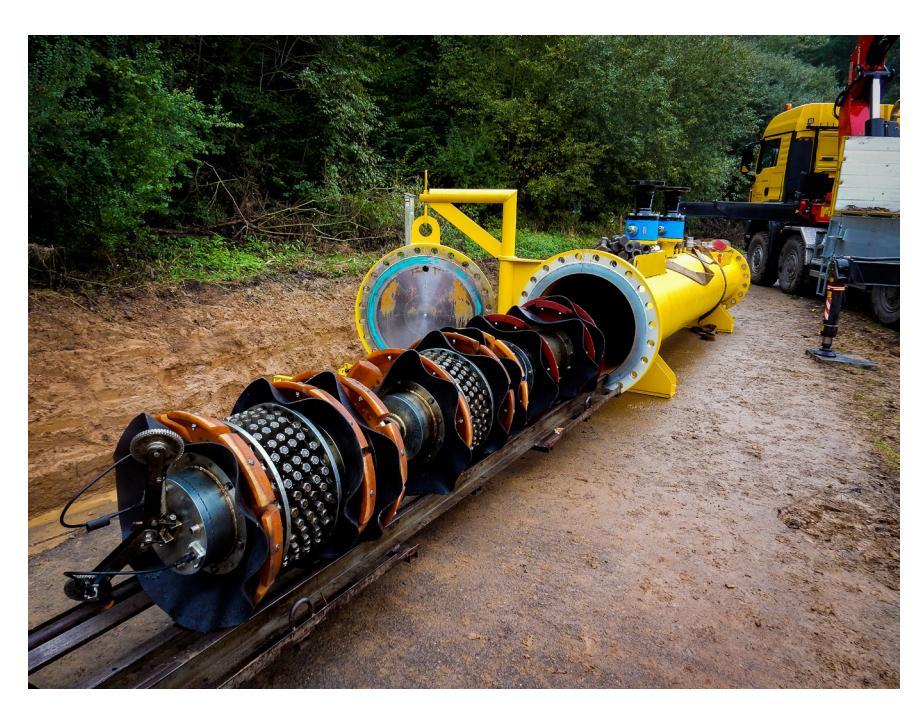
Figure 5. Launching/receiving pig trap.

CEPS purpose-designed, manufactured and installed special pig traps for launching and receiving the ILI tool (Figure 5). Water from the Otava River was used to propel the pig. After the inspection, the water was drained back into the river. To maintain the velocity of the ILI tool above 0.5 m/sec., as recommended by the tool supplier, the water pumping flowrate had to be at least 540 m³/h. During the inspection the whole pipeline section (4560 m³) was filled with water. Water was pumped from the river into the pipeline indirectly. Low pressure pumps were feeding the water into two mobile container tanks. From the tanks, water was pumped into the pipeline section by two parallel diesel-fuelled pumps FPMU 420/60 MARLY – the maximum flowrate was 2 x 420 m³/h, the maximum discharge pressure was 63 bar.
