Comprehensive approach to ensuring the integrity of high-pressure gas pipeline DN 400

CEPS a.s.
Jesenice u Prahy
Czech Republic

T.D. Williamson Polska
Warsaw
Poland

A concrete example of this integration is revalidation of 55 km older gas pipeline DN 400 in south-western Poland

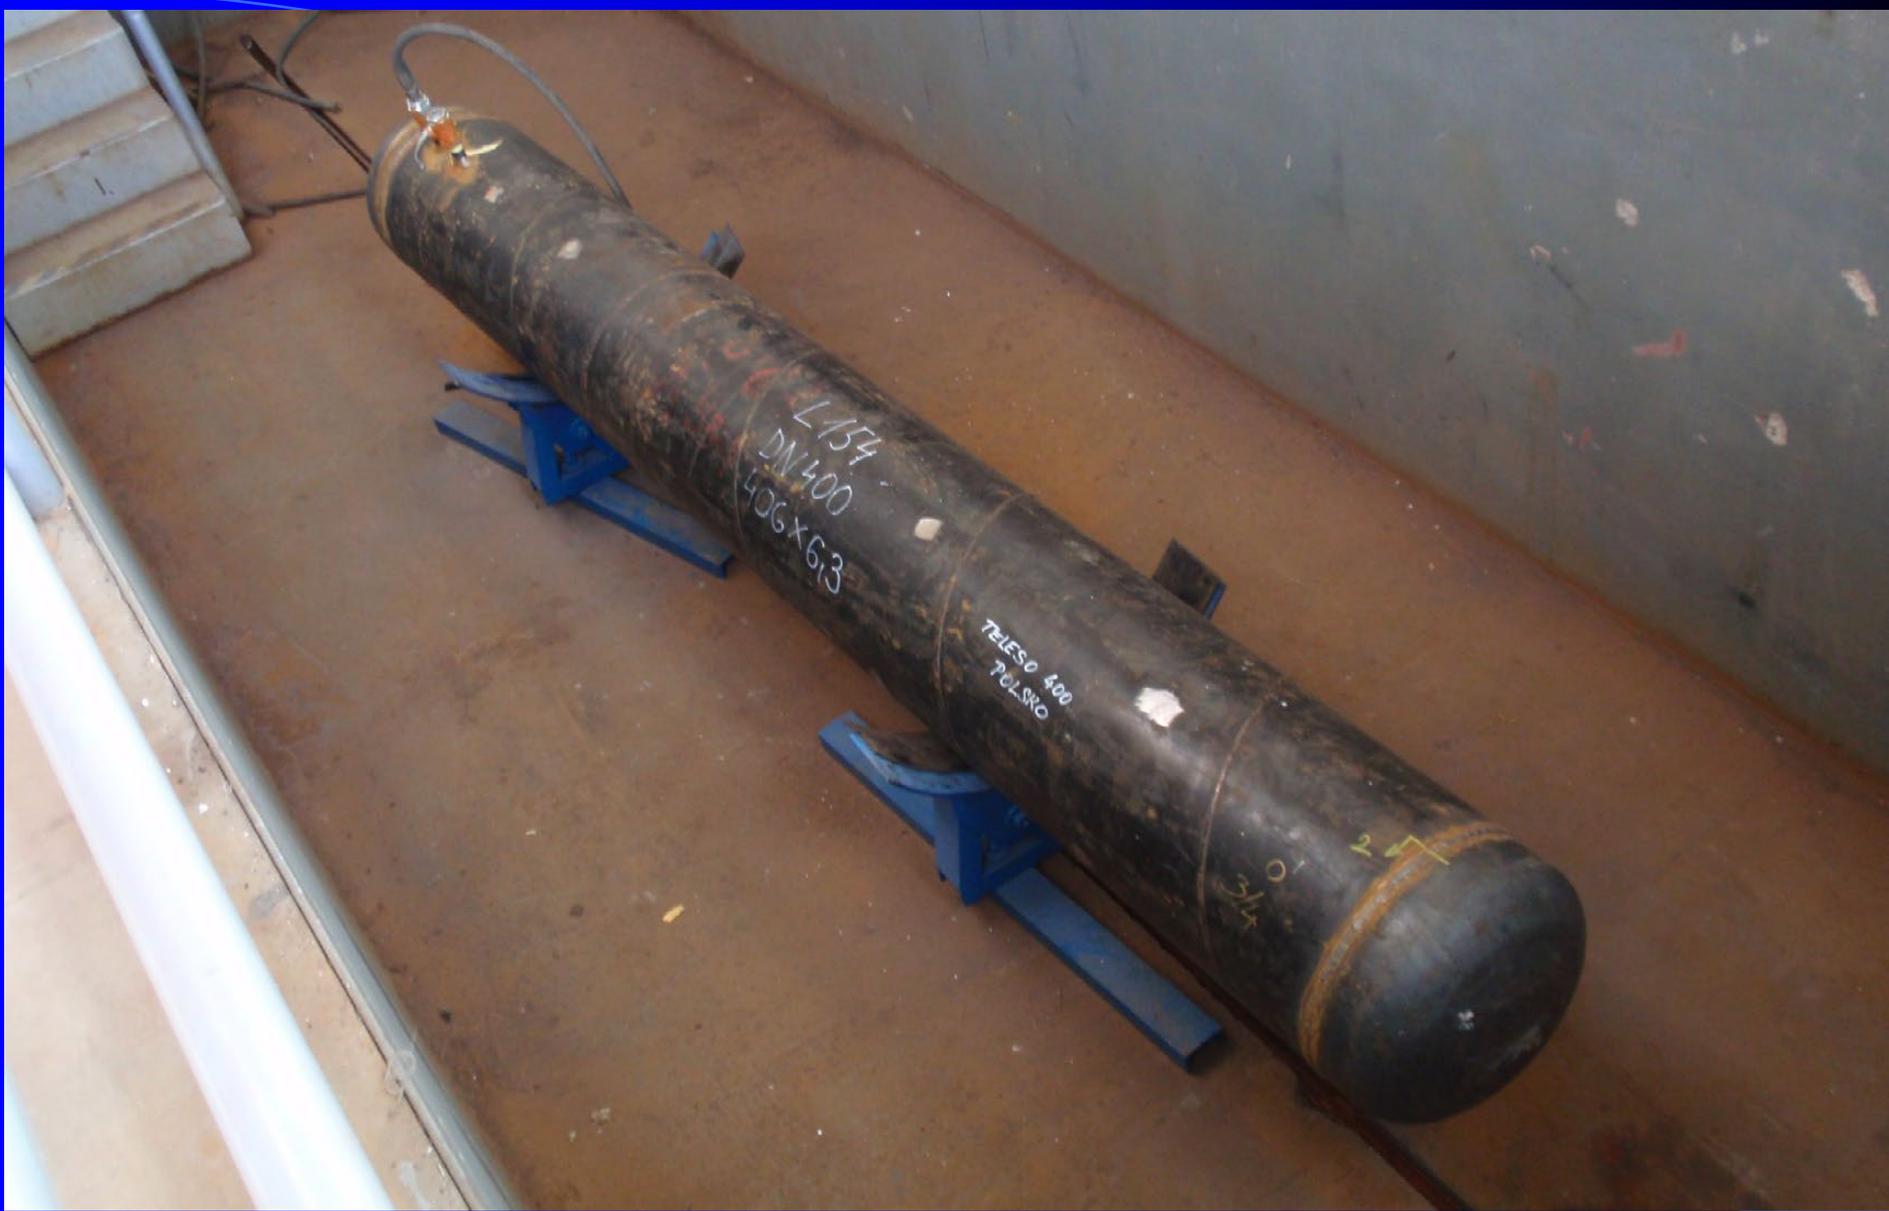
Pipe body vessel was at both ends closed and fitted with nipples and valves for connection of pressure sensors and high-pressure hoses for inlet and outlet of pressure water.

The pipe body vessel was gradually pressurized to the yield strength to a value of permanent integral circumferential deformation $\varepsilon = 0.05\%$

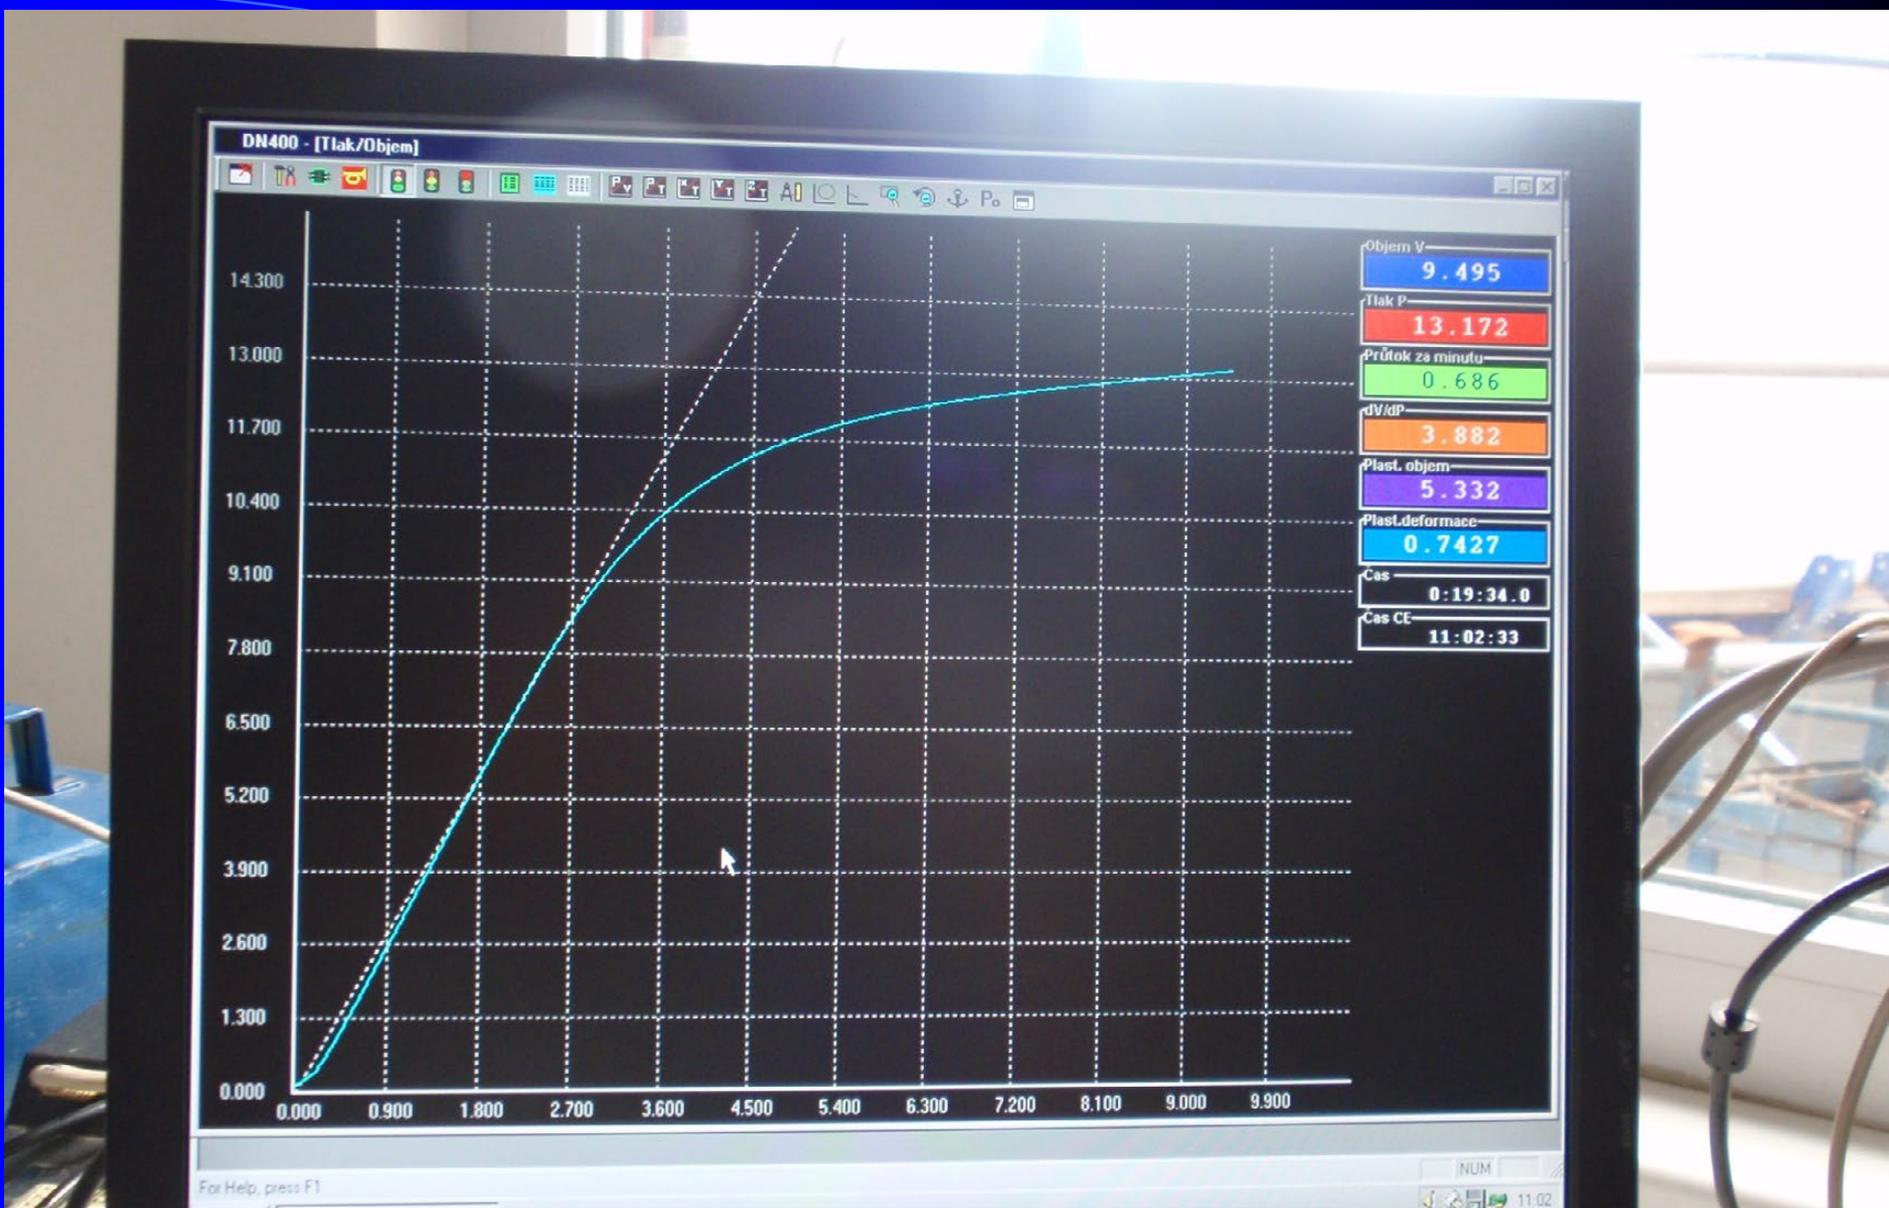
On-line measurement of dependence p-V

After integrity test the pipe body vessel was gradually pressurized to the ultimate strength limit until destruction of the material.

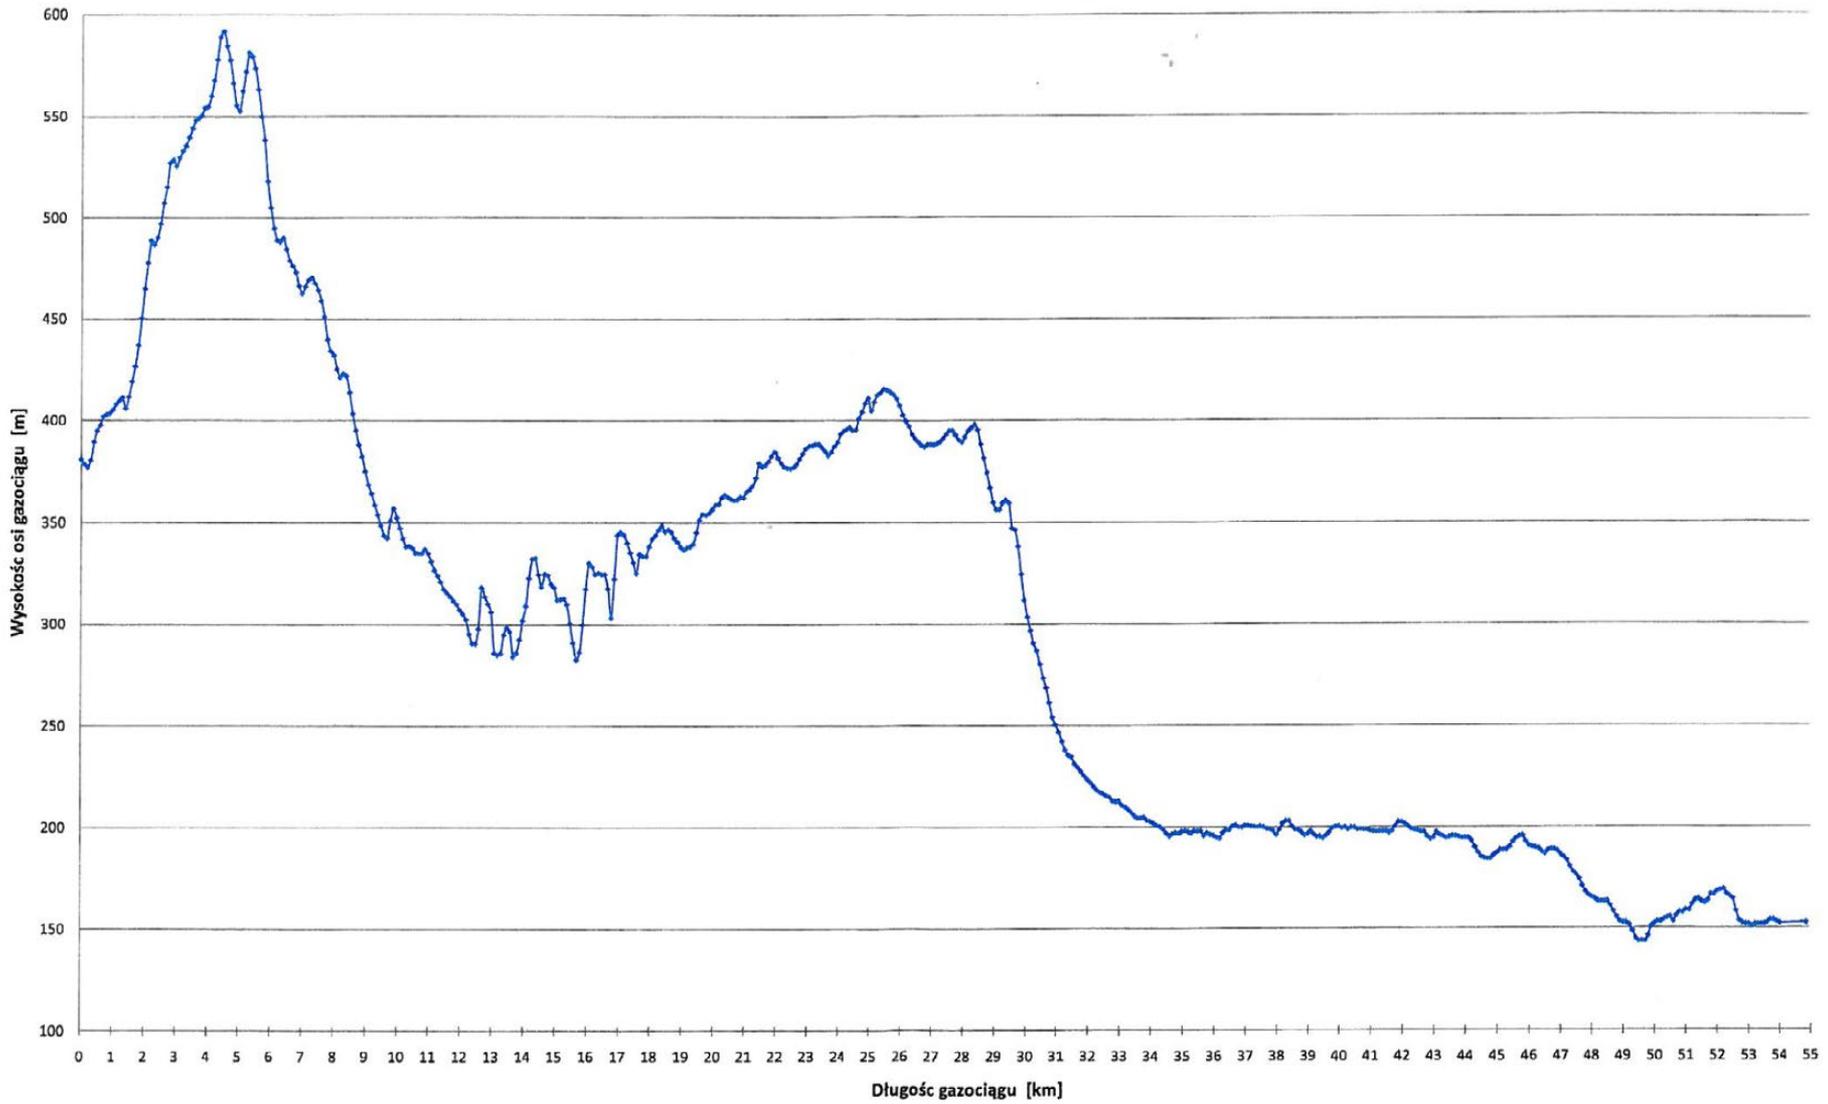
Longitudinal profile of the pipeline

Division of pipeline into working sections was **extremely difficult**, because territory which the pipeline leads is very **mountainous**.

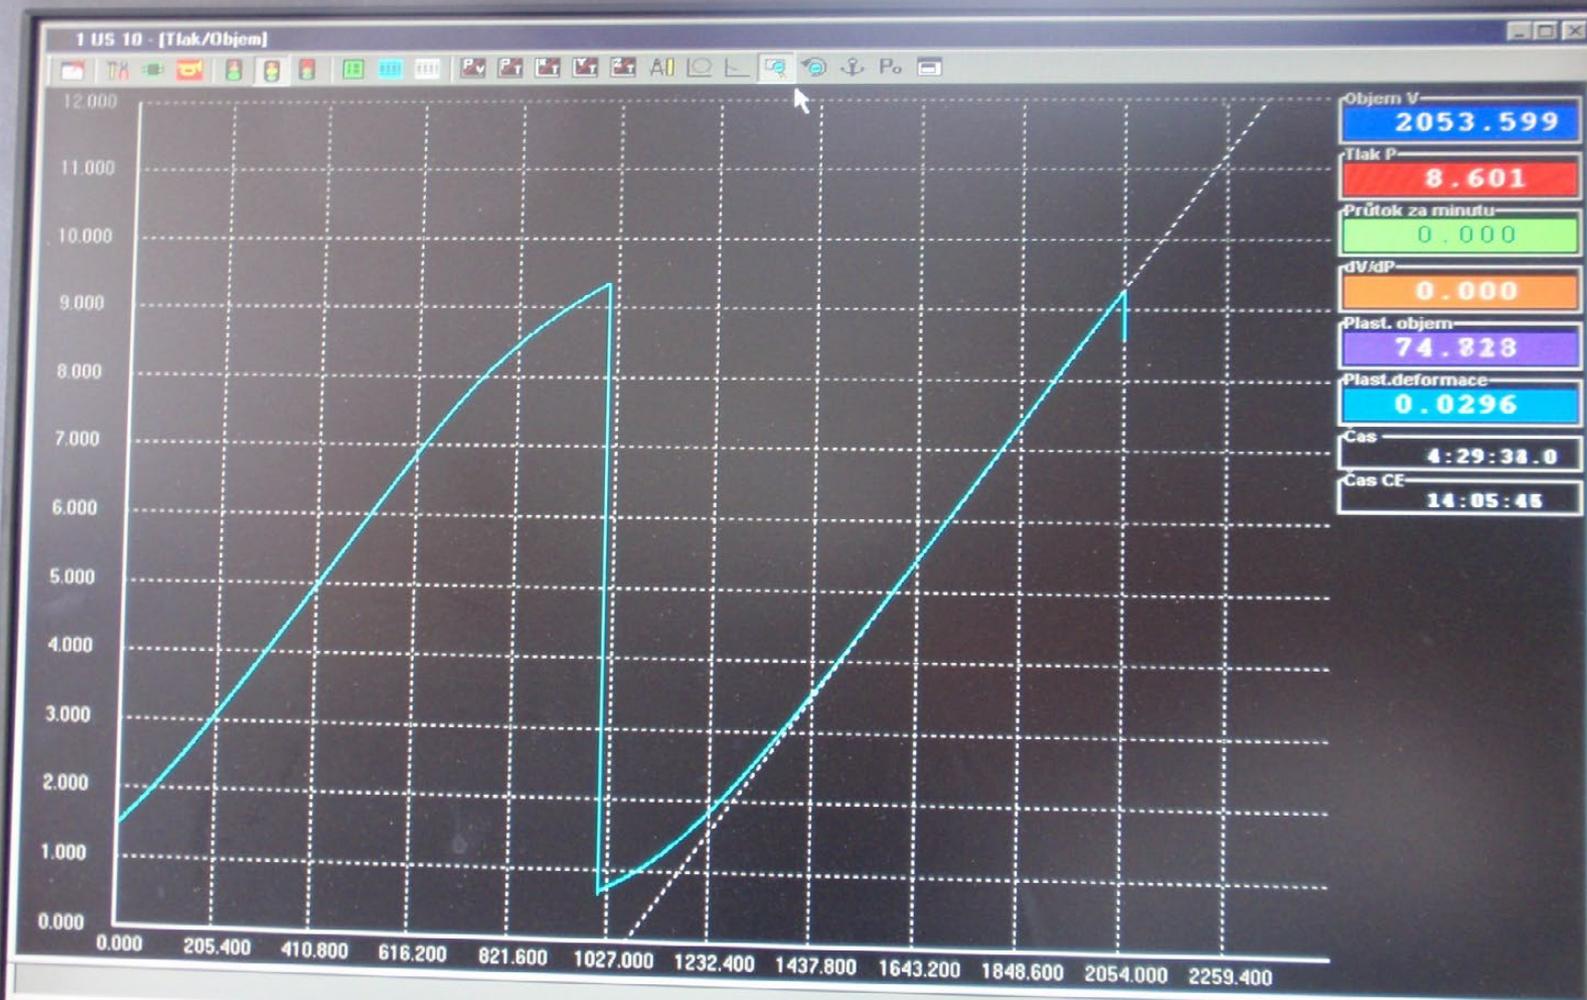
On-line measurement of p-V

During of integrity tests two destruction of the pipe occurred

- The first time on part of pipeline which was built 15 years ago in 1997.
- The second time a leak was detected in the section built in 1991–1992.

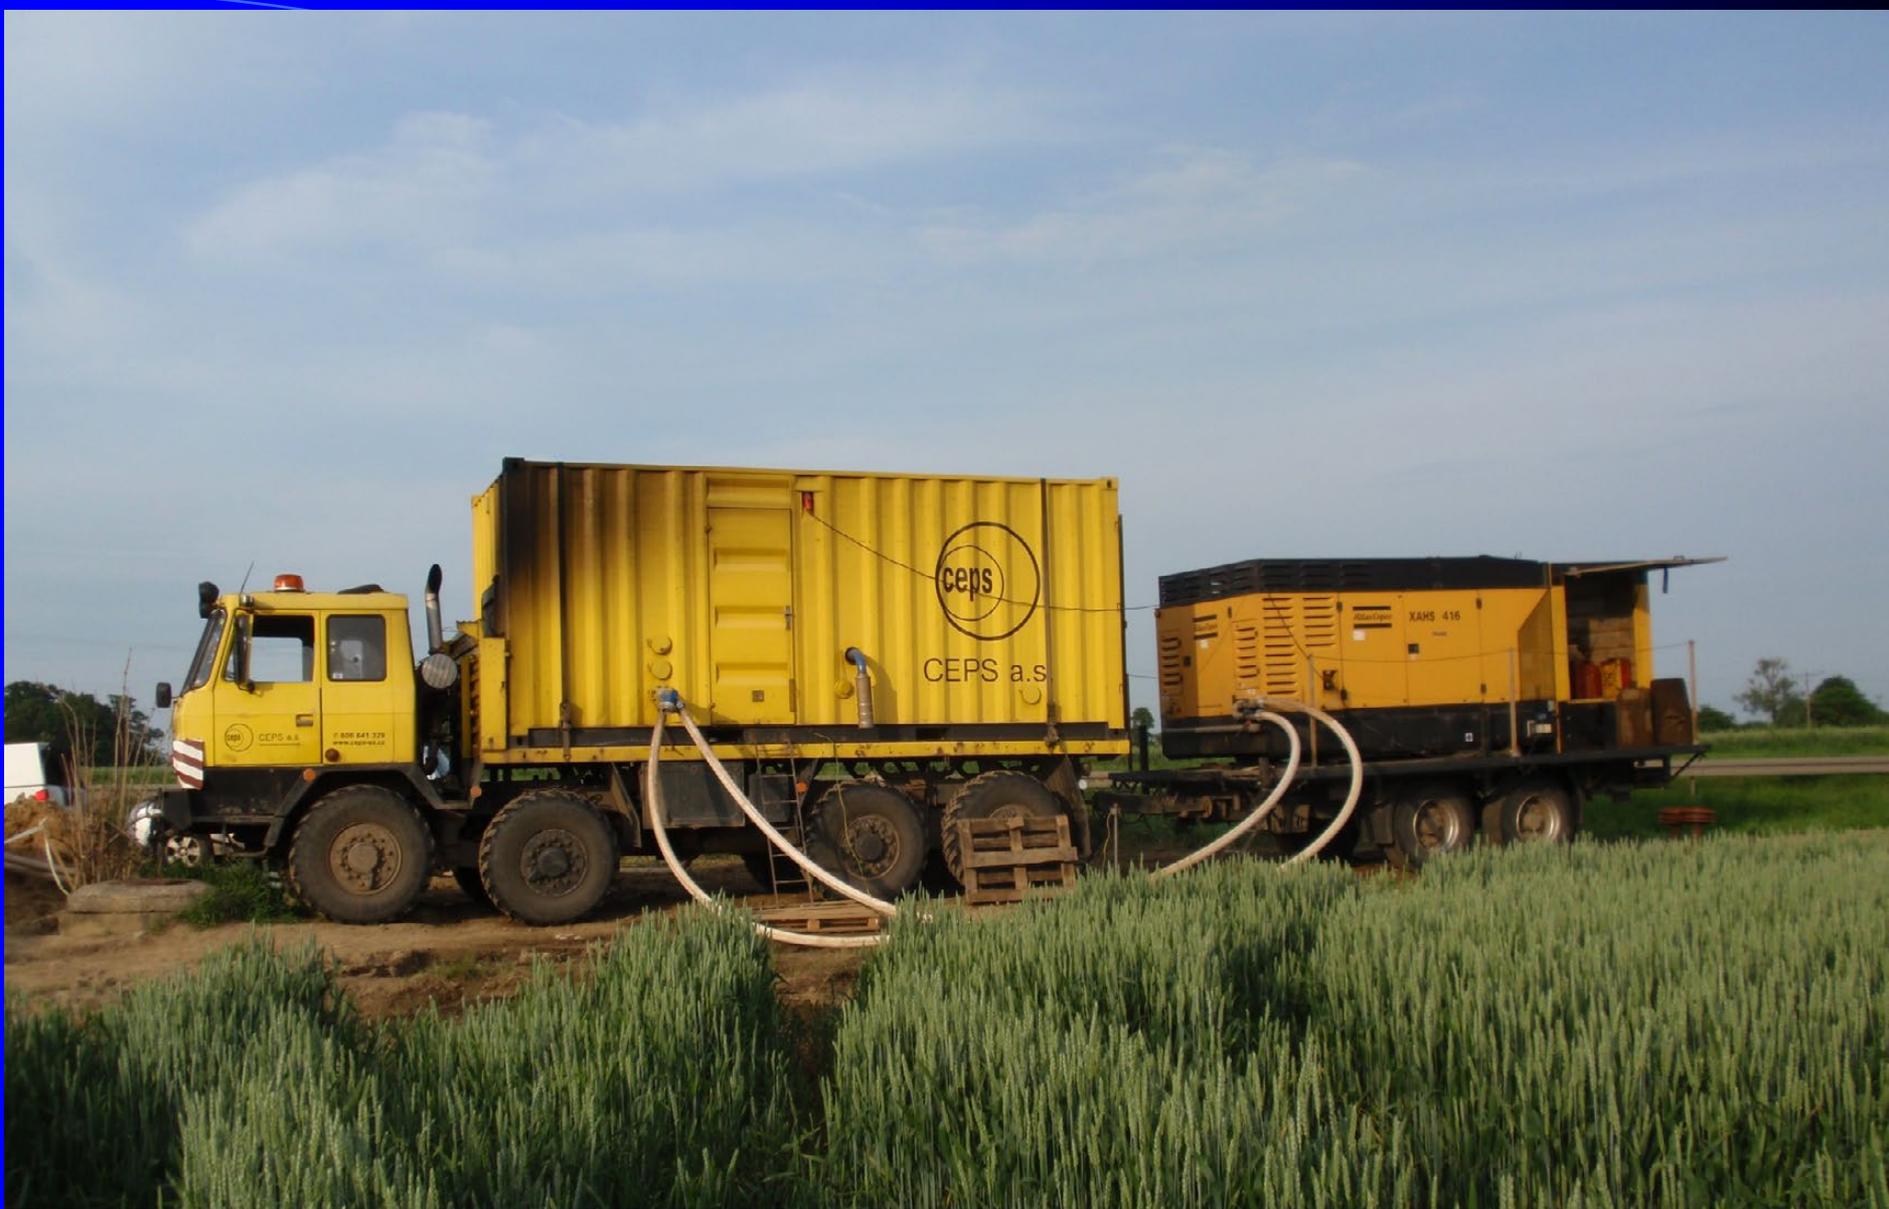
The mobile drying unit

After the performed integrity test and after connection of the working sections of each working units was the pipeline dried by superdry air up to dew point $-20\text{ }^{\circ}\text{C}$ of air leaving from pipeline.
